**US Army Corps
of Engineers**

CERL Technical Report 99/66
August 1999

Technical Assistance To Supplement Installation of Low NO_x Boilers at the Pentagon Heating and Refrigeration Plant

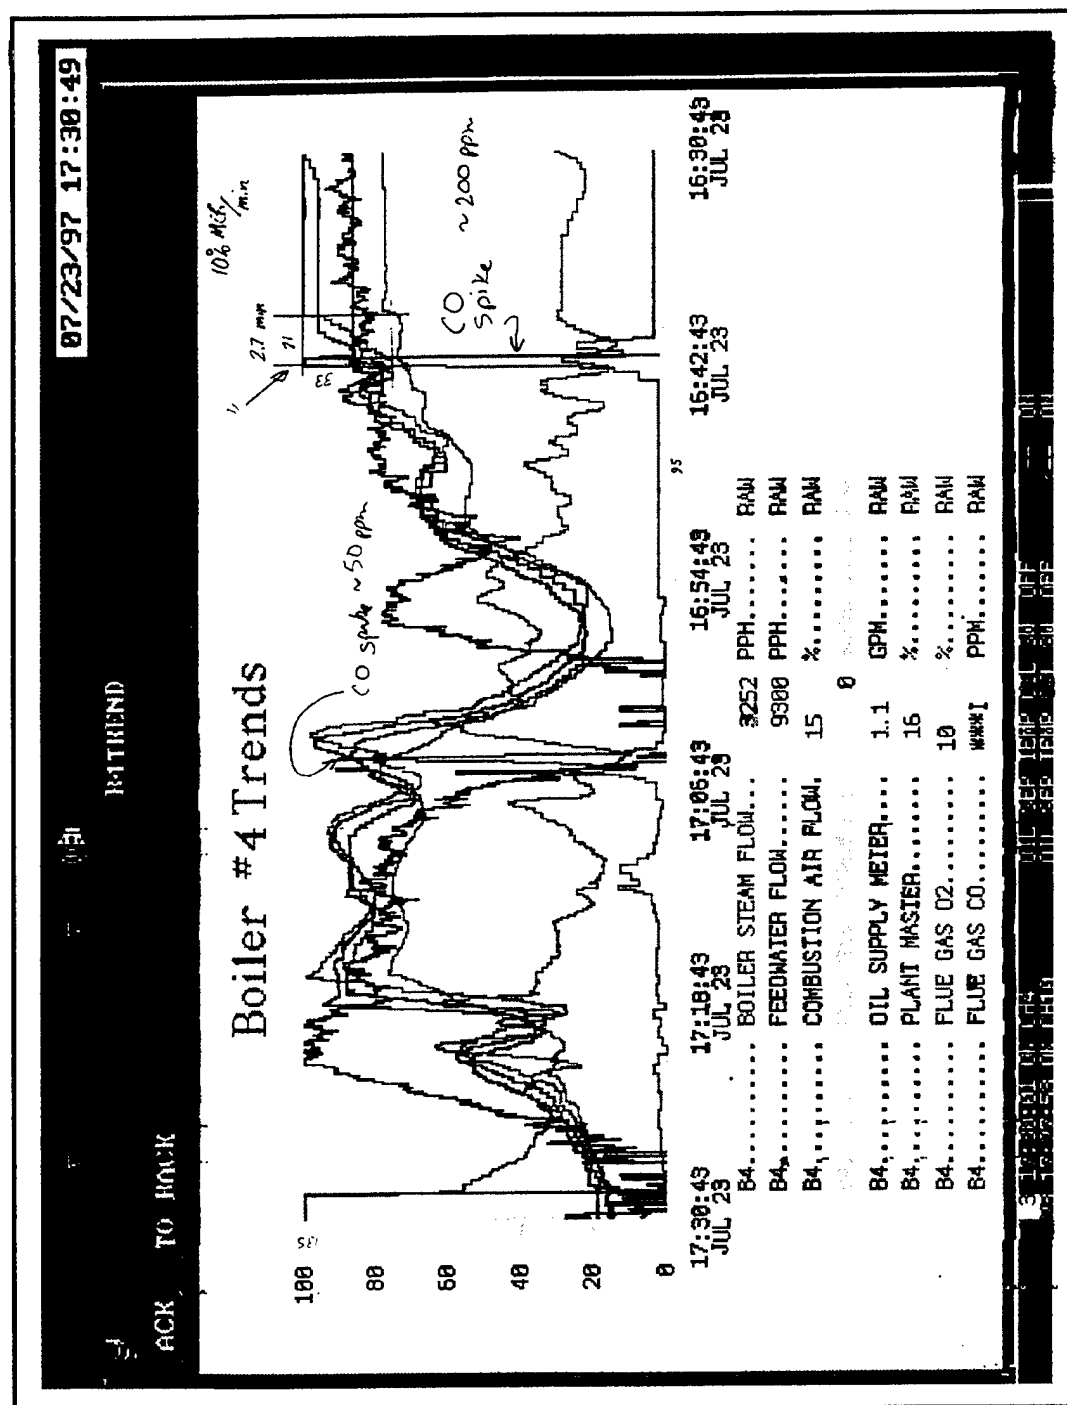
Figure 9. DCS printout showing boiler No. 4 trends.

The PRO letter also states that "unexpected carbon monoxide excursions were witnessed 7-9 May 1997 which were possibly due to DCS communications failure." When operating above the turndown limit of 6 to 1, the burners performed satisfactorily. On 23 July 1997, when changing the steam load manually at very high rates (greater than 10 percent Max Continuous Rating [MCR] per minute), there were two CO excursions above 50 PPM when near full load followed by dropping load quickly. (Figure 9 shows the DCS printout.) It was not clear to the team why the excursions occurred under these abnormal operating conditions. Although the load change was abnormal, a parallel metered control system should have been able to handle that change. The control system did respond to the excursion appropriately and increased air to quickly reduce the CO levels. The fuel train may need closer examination to precisely identify the cause of the CO excursion. The control system characteristic curve may need adjustment. For an unknown reason at 16:40 on 23 July, the controls let the fuel valve remain fully open for 30 to 60 seconds after the airflow was being reduced. It appears that the control system ruled that the airflow was so excessive that the fuel did not need to be reduced until the airflow signal had dropped significantly. One factor may be that the fuel oil supply pressure was increased slightly to try to reach full load. The burner did perform safely under normal load transients. However, if the current airflow-metering scheme is used, the team has recommended that the control system characteristic curve be inspected and recalculated.

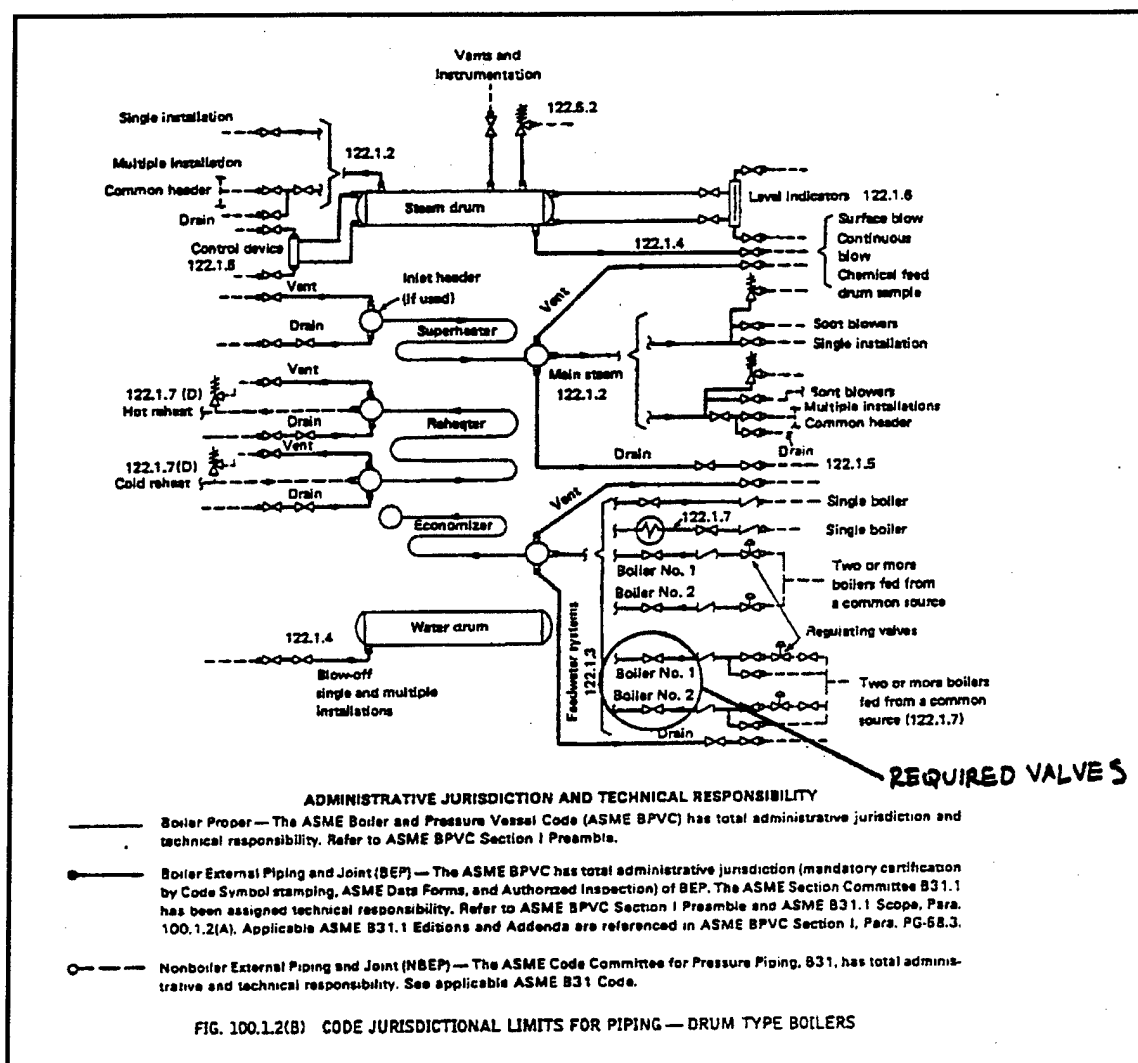
Figure 10. ASME Code B31.1, Fig 100.1.2(B).

- An ASME Boiler and Pressure Vessel required valve is missing in the feedwater piping. Figure 10 shows ASME Code B31.1, Fig 100.1.2(B). There should be a stop valve isolation valve between the check valve downstream of the feedwater regulation station check valve and the economizer.
